FINAL REPORT FOR ENERGY-EFFICIENT, MOLD-RESISTANT MATERIALS AND CONSTRUCTION PRACTICES FOR NEW CALIFORNIA HOMES

Prepared By:
Gas Technology Institute

PIER FINAL PROJECT REPORT

August 2008 CEC-500-2007-036

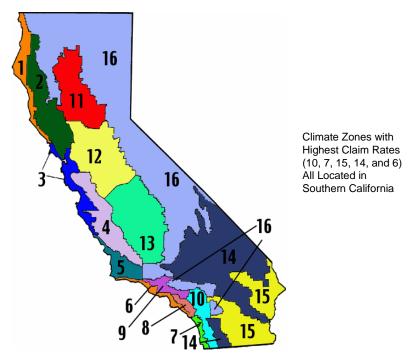
Figure 2. California climate zones with highest water damage claim rates are located in Southern California.

Analysis of the database identified several trends of interest. On average during the period from 2000 through 2002, 27.2 water damage claims per 1000 policies were experienced annually statewide. Of California's 16 climate zones, zones 10, 7, 15, 14, and 6 (in descending order) experienced above average water damage claim activity. All five are in Southern California (Figure 2). Of California's 58 counties, Riverside, Orange, San Diego, San Bernardino, Contra Costa, Ventura, Solano, and Kern (in descending order) experienced above average water damage claim activity. Of these counties, 5 were in Southern California, and 2 were in the area east of San Francisco Bay (Figure 3).

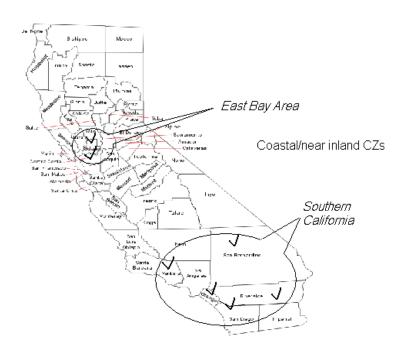
Figure 3. California counties with highest water damage claim rates

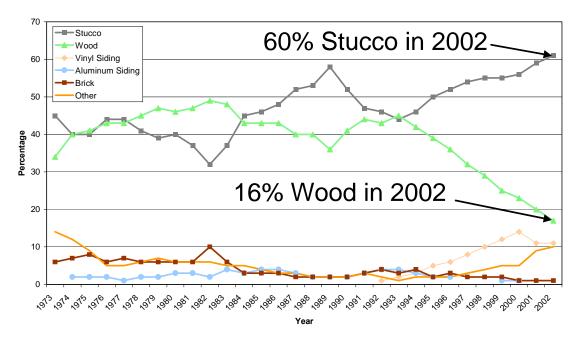
Percentage of New Single-Family Houses Completed by Siding Type for Years 1973 Through 2002 for Western Census Region

Figure 4. Stucco wall construction trends in western states Source: Gas Technology Institute

Stucco wall construction presents unique challenges to builders. Since it has such a high market penetration rate, stucco wall assemblies should be a focus of laboratory research efforts on this project.

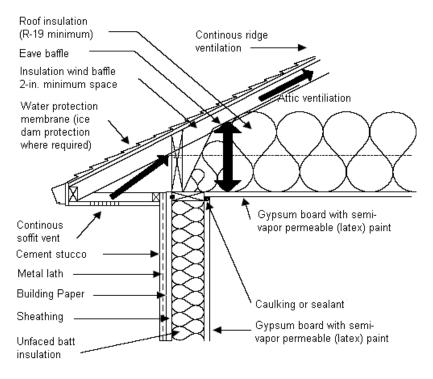
Figure 5. Baseline roof and wall assembly

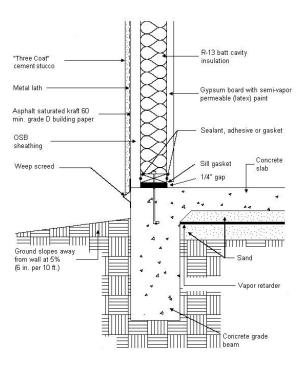
Figure 6. Baseline floor slab

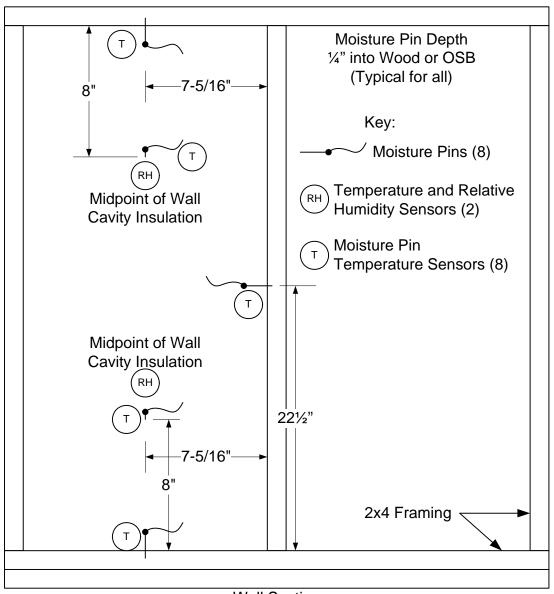
Wall Section

Figure 7. Wall assembly DAS sensor locations

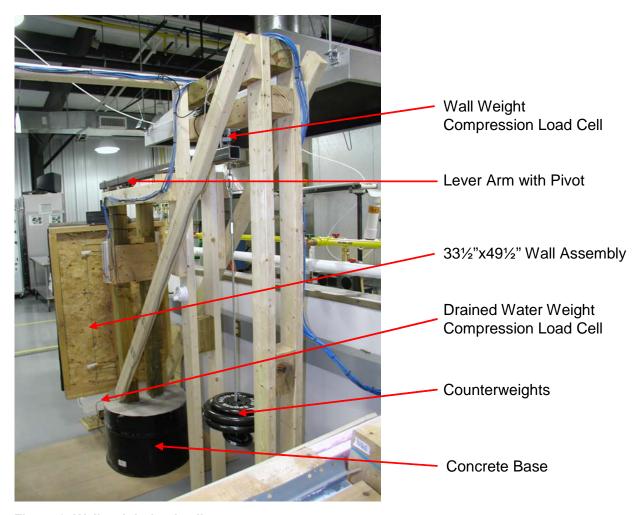
Figure 8. Wall weight load cell apparatus

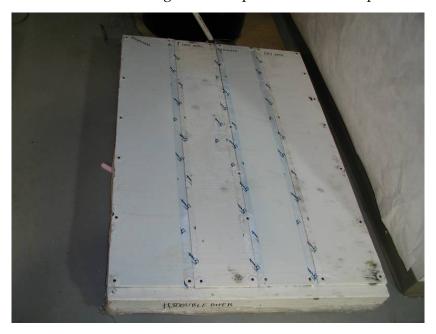
Both types of mold resistant gypsum panels exhibited significant resistance to mold growth compared to conventional gypsum panels, but only on the surfaces of the panels themselves (Figures 9 and 10). The remainder of the wall assembly experienced significant mold growth.

Figure 9. Anti-microbial treated gypsum panels vs. conventional gypsum panels

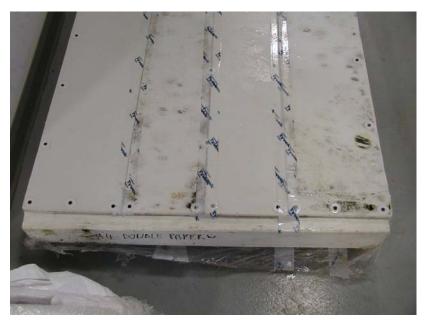
Figure 10. Fiberglass gypsum panels vs. conventional gypsum panels

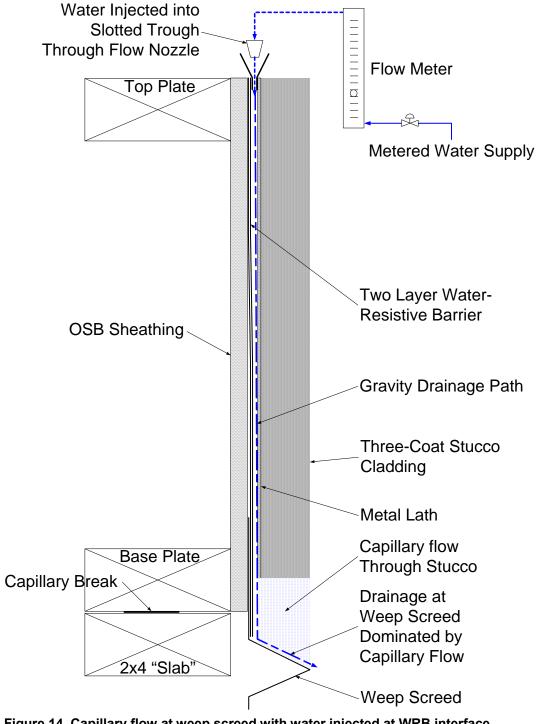
Figure 14. Capillary flow at weep screed with water injected at WRB interface Source: Gas Technology Institute

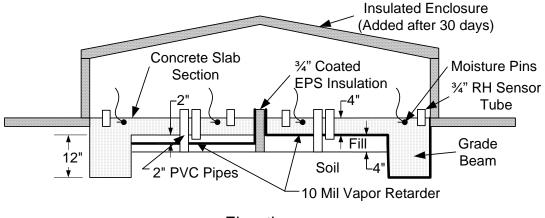
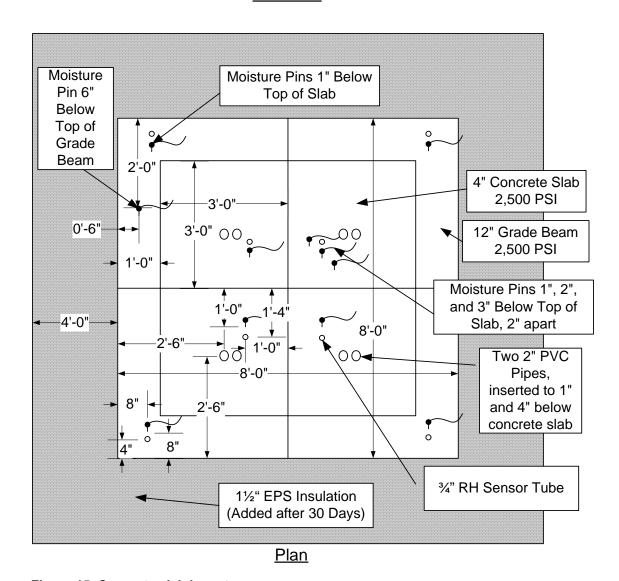
Elevation

Figure 15. Concrete slab layout

Slabs were poured by hand on October 14, 2004, using nominal 2,500 pounds per square inch (psi) concrete. Initially the concrete slabs were exposed to ambient conditions and not under cover. Slabs were covered with insulated enclosures, and ground insulation was added on November 24, 2004. Slabs remained covered for the remainder of the test period until August

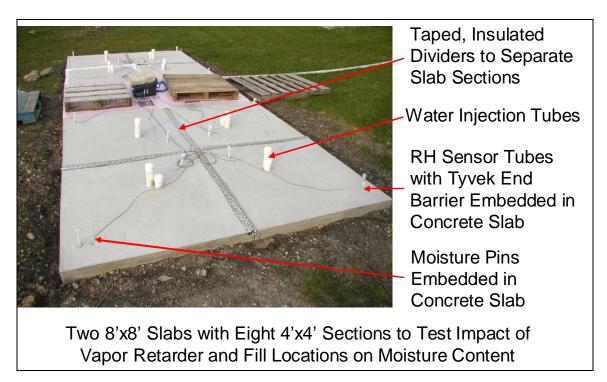
Figure 16. Concrete slabs (looking south)

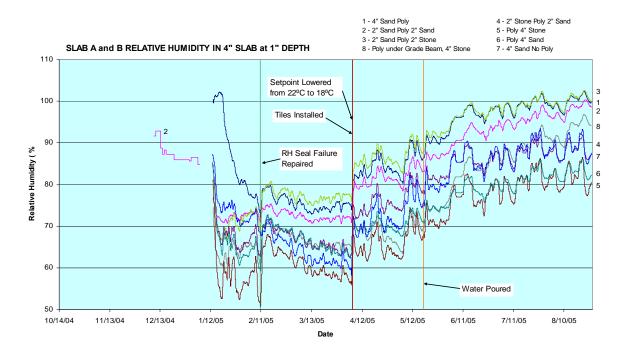
Relative humidity at 1-in depth in all 8 slab sections fell below 80% within 4 months after pour in both the 4-in slab and 12-in grade beam, with significant changes in relative humidity occurring 3 months after the pour, shortly after sensor installation (Figures 17 and 18). Relative humidity variations between the 4-in slab and 12-in grade beam suggest that no entire slab section was ready for floor covering until 4 months after the pour.

Figure 17. Slab A and B relative humidity profile in 4in slabs at 1-in depth

The data suggest that moisture content may be a reasonable predictor of changes in relative humidity, but does not appear to be a good predictor of exact relative humidity values in any individual slab section or moisture content level.

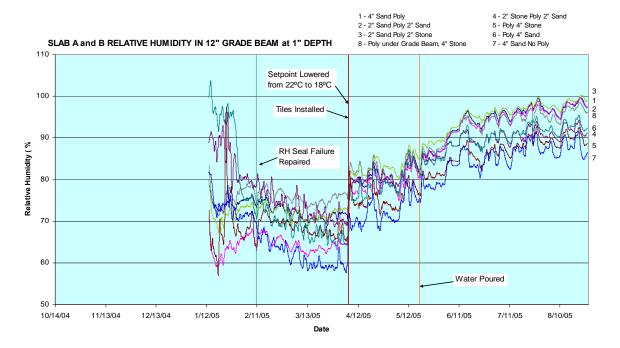
Figure 18. Slab A and B relative humidity profile in 12-in grade beam at 1-in depth

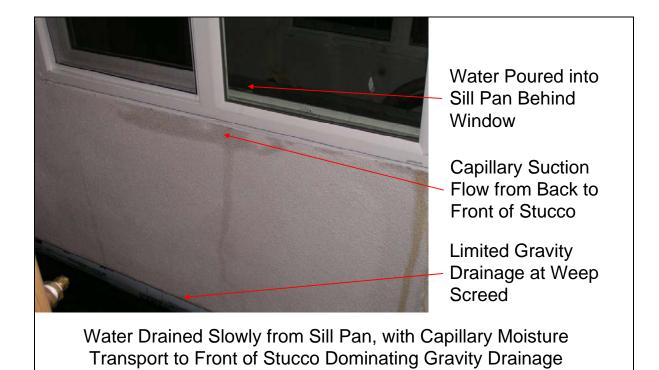
No Observed Leak, Sill not Protected

Observed Leak

Figure 19. Capillary-dominated drainage with water poured into sill pan

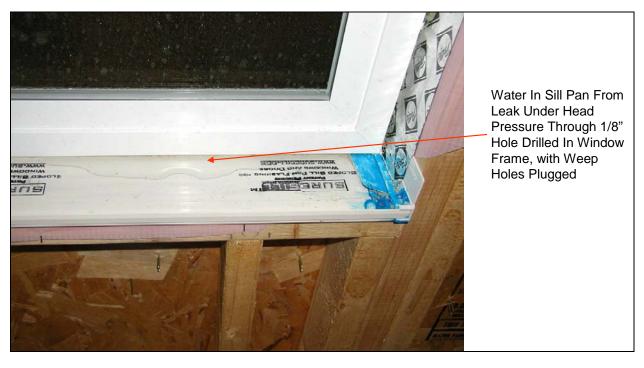
Figure 20. Water from window frame leak collected in sill pan flashing

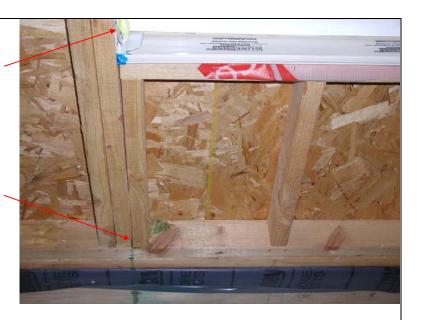
Leak Point of Origin at Junction of Sill Pan, Stucco, and WRB

Dyed Water Shows Visible Leakage Between Studs on Interior Side of OSB

Leak to Interior Side of OSB Sheathing Due to Capillary-Dominated Drainage and Head Pressure from Water in Sill Pan

Figure 21. Leakage with sill pan and OSB sheathing

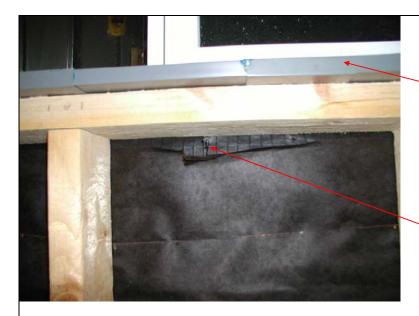
Sill Pan with Water Collected from Window Frame Leak with Plugged Weep Holes

Leak at Staple Pinhole in Sill Flashing (Staple Missed Sill)

Figure 22. Leakage with sill pan and open frame construction

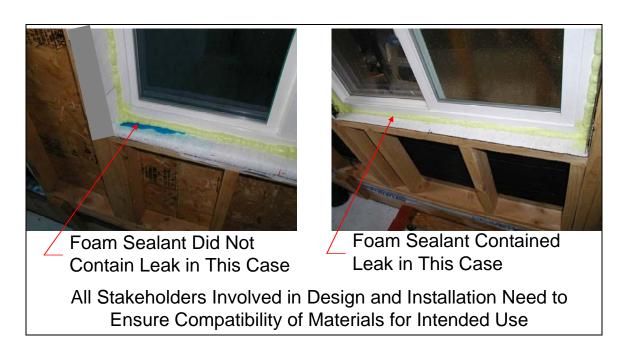
Figure 23. Leak with foam sealant due to misapplication/incompatibility

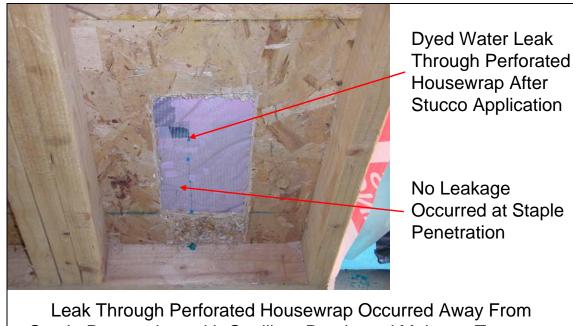
Staple Penetration, with Capillary-Dominated Moisture Transport

Figure 24. Leak through perforated housewrap during 15-minute blue dye spray test

- Stucco with freshly caulked window frame prevented liquid water penetration at window/wall interface, even with reverse shingle-lap
- Stucco cladding with caulk stops bulk water flow.
- Capillary suction transports moisture to interior side of stucco.
- Low pressure expanding foam sealant (an air barrier) improved WRB performance at sill in some cases (Figure 23).
- Sealant contained leaks when full seal was achieved.
- Sealant did not contain leaks when misapplied or incompatible with substrate
- Perforated housewrap leaked through perforations with and without stucco cladding.
- No observable leaks occurred on interior side of OSB sheathing at window/wall interface.
- Leaks occurred when the moisture drainage mechanism was either liquid water or possibly capillary moisture flow after application of stucco cladding based on destructive disassembly (Figures 24 and 25).

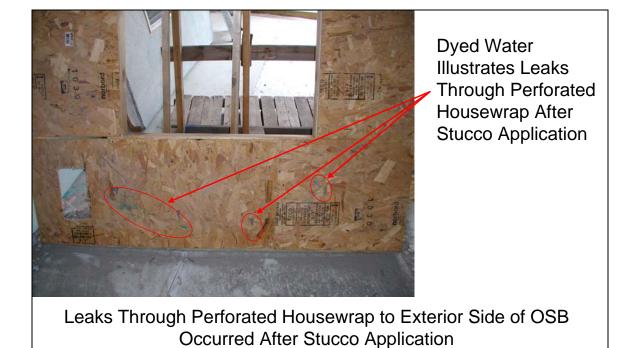
Figure 25. Leaks through perforated housewrap to OSB after stucco application

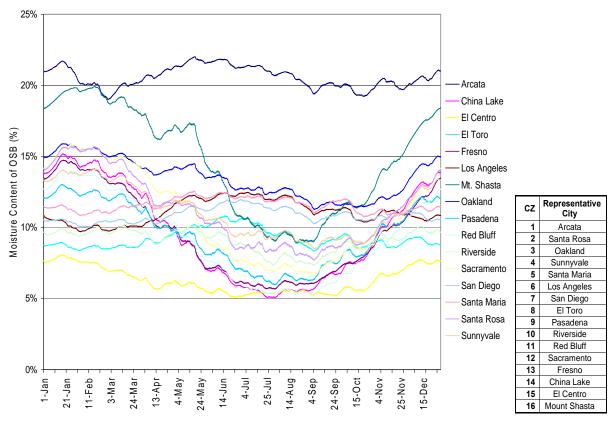
Results in California Climate Zone 16 (considered the most adverse climate zone for managing moisture) showed only a small reduction in moisture content in OSB sheathing as WRB permeance increased. The wall systems in 15 of the 16 Climate Zones showed little potential for OSB decay irrespective of wall construction or WRB option. Except for Climate Zone 1 (Arcata), only modest annual hours, if any, with OSB moisture content over 20% were exhibited by any of the wall systems (Figure 26).

Figure 26. Percent moisture content of OSB in wall 1-3A4A5B in all 16 climate zones

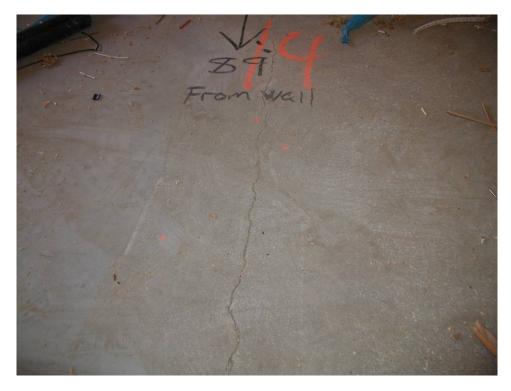
Figure 32. Slab crack after post tensioning and enclosure, slab 25

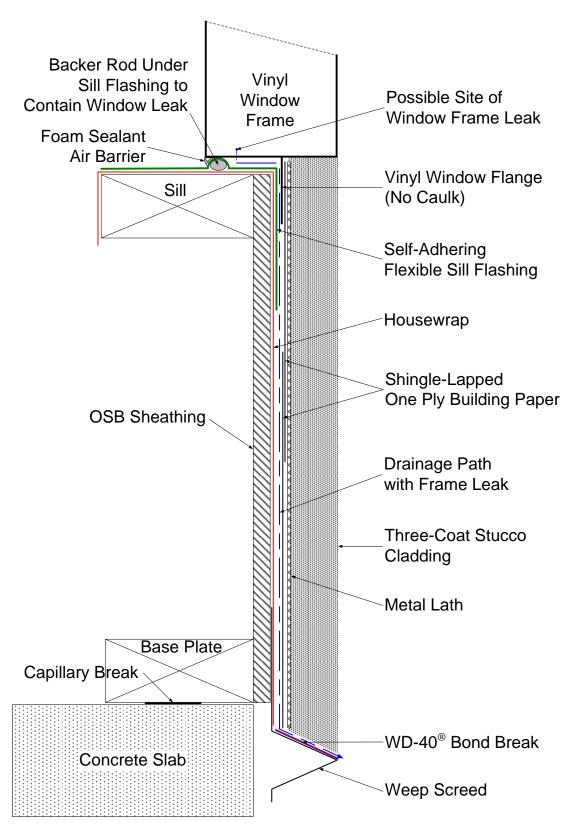
Figure 34. Housewrap/sill flashing schematic with drainage path

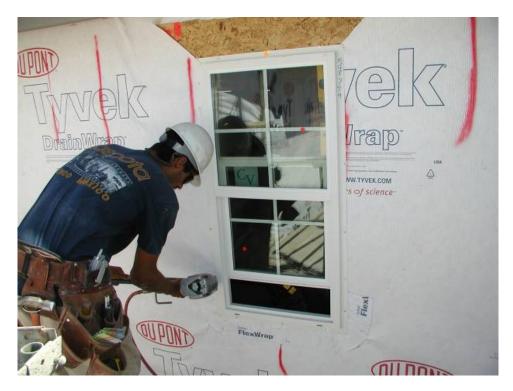
Figure 35. Window installation, ASTM E 2112-01R Method A1, Lot No. 76

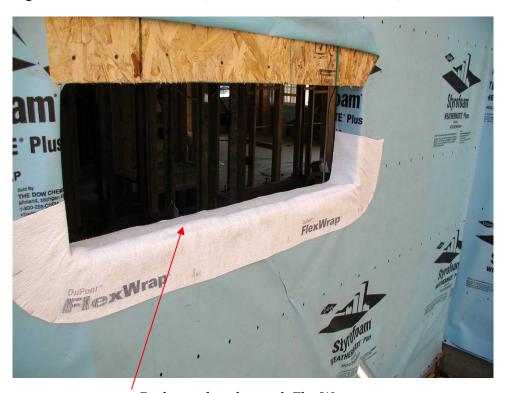
Backer rod underneath FlexWrap™

Figure 36. Flexible sill flashing with %-in backer rod backdam, Lot No. 78

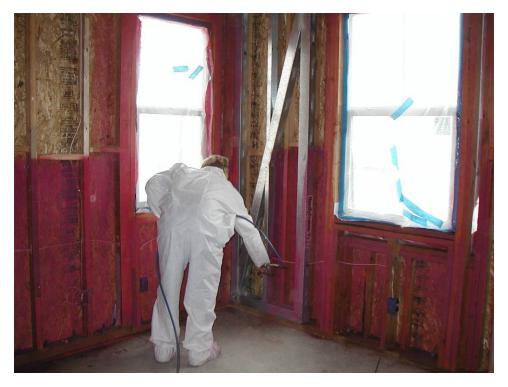
Figure 37. Application of 42-42 in first living area, Lot No. 77

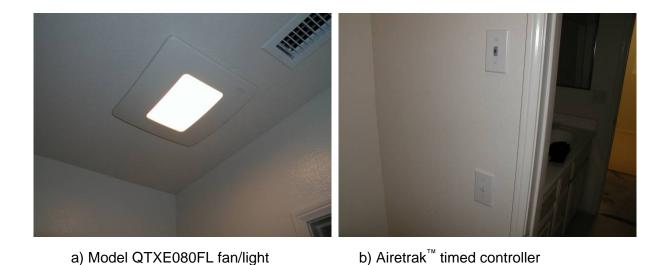
Figure 38. Continuous duty bath fan/light and timed controller installation, Lot No. 77

- Automated bathroom relative humidity control is challenging, but worth investigating as a benign control strategy (Figure 38). Its goal is to remove residual moisture automatically whenever needed and when the manual switch is off. Since the user may operate the exhaust fan manually when generating the moisture load (e.g., due to bath or shower), its incremental benefit is variable. Low noise, continuous duty fans are a key element of this strategy. Both builders perceive the low noise fans and relative humidity controller to have potential marketing benefits and plan to provide future feedback on the value they attach to this feature.

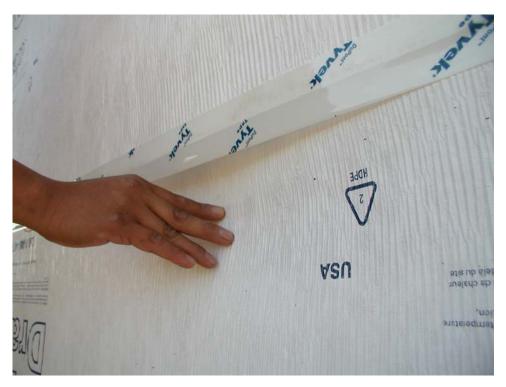
Figure 39. Poor tape adhesion in open frame construction

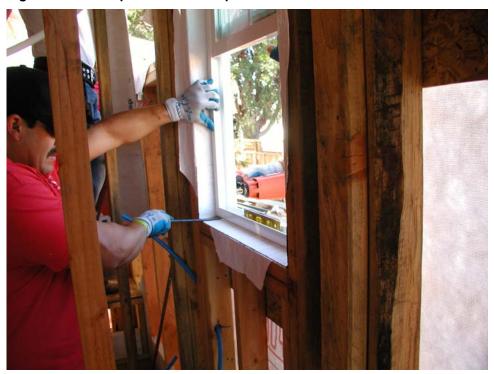
Figure 40. Good compatibility between flexible sill flashing backdam and leveling tool
